GMHC - Greater Metropolitan Housing Corporation
15 S 5th St Suite 710
Minneapolis MN 55402
RE: 7324 17 AVE S

Lead-Based Paint Inspection and Risk Assessment Report

Hennepin County Housing, Community Works & Transit Dwelling Sketch

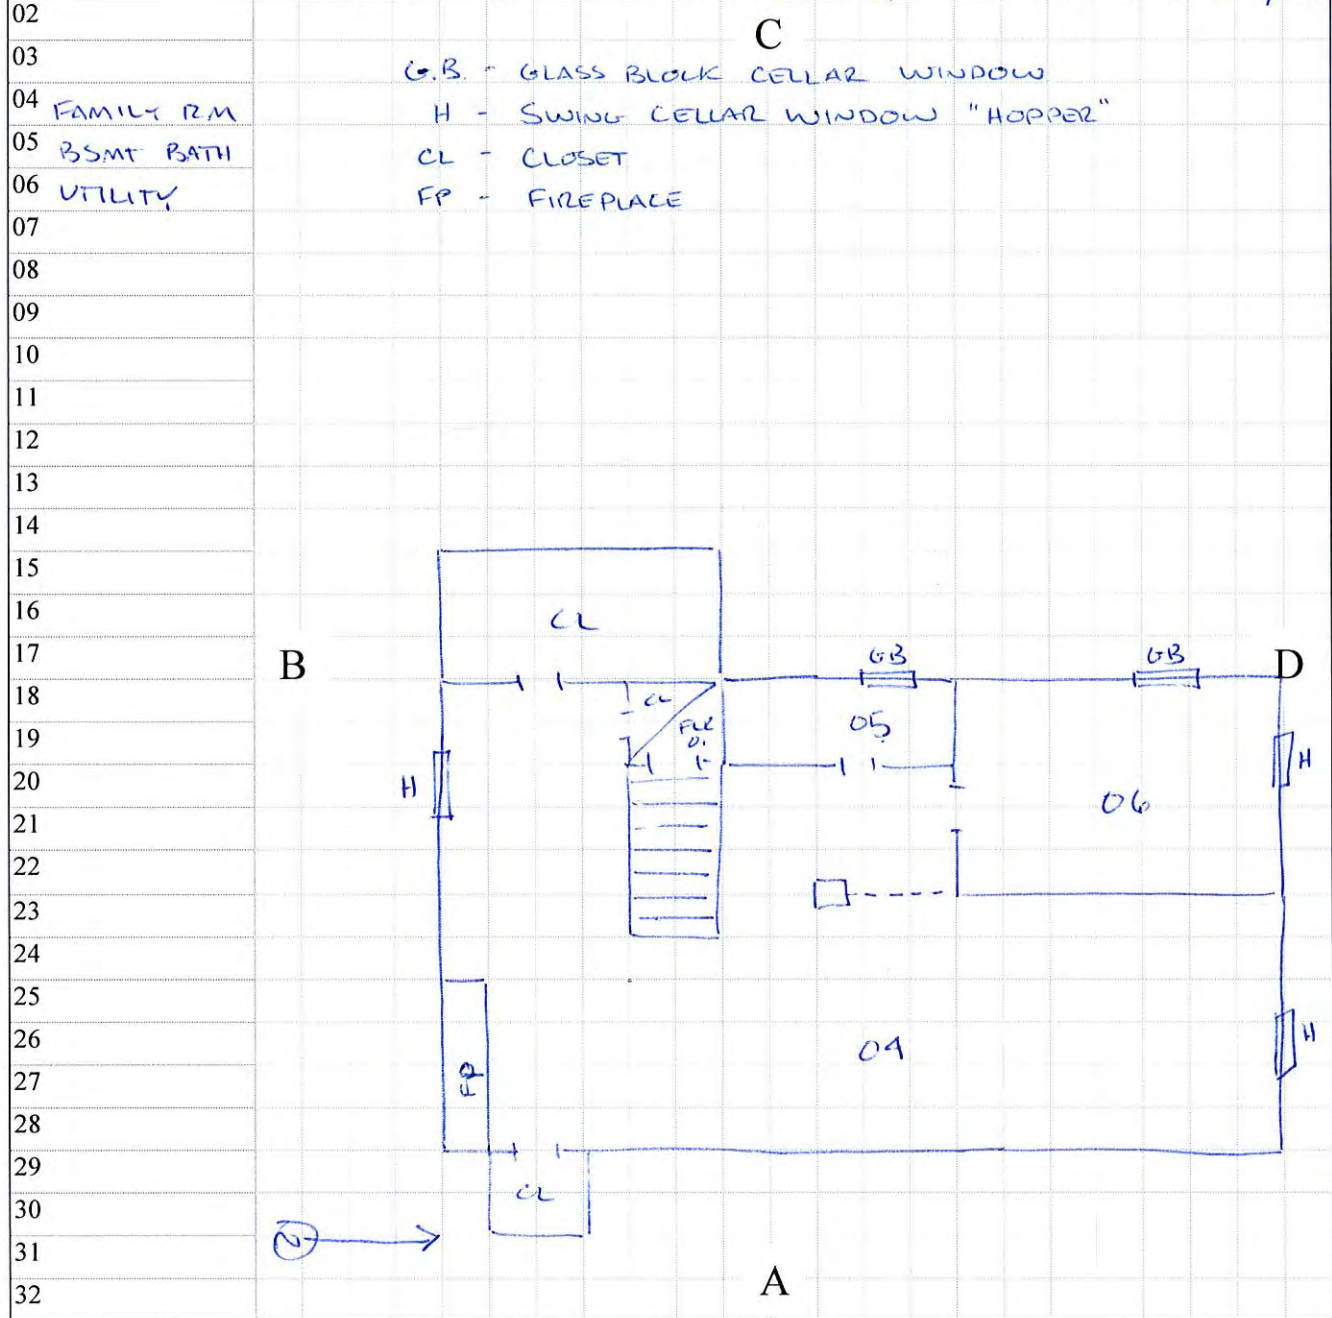
Case Type		Tracking #	Property Address	Dwelling Unit	
GMHC			7324 17 th Avenue S, Richfield	SF	
Risk Assessor	Page Number	Exterior / Floor Level		Drawn By	Date
Jones	Page 2 of 3	BASEMENT		B.J	3/21/13

Hennepin County Housing, Community Works & Transit Dwelling Sketch

Street used in address of residence: 17 AVE S.

This sketch is not to scale.
